Manhole Inspection Summary

Manhole # S33AA1014MH

Insp Date: **3/5/07 2:34 PM**

Location Address: **3409 GREENWAY**

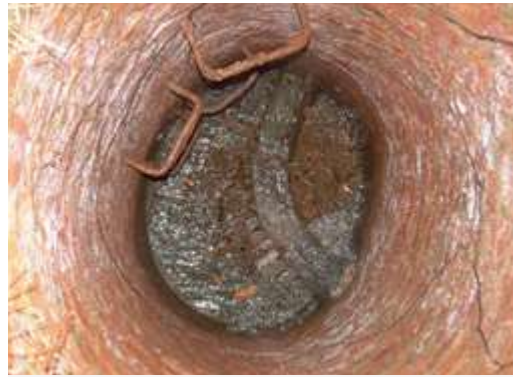
Top View

Steps Count: **3** Missing: **0** ☒ **Corroded**

Surcharge ☒ **Evidence Of Surcharge** Depth: **2** (ft.) ☐ Active Surcharge Present

Corroded steps. Evidence of surcharge - Bench debris.

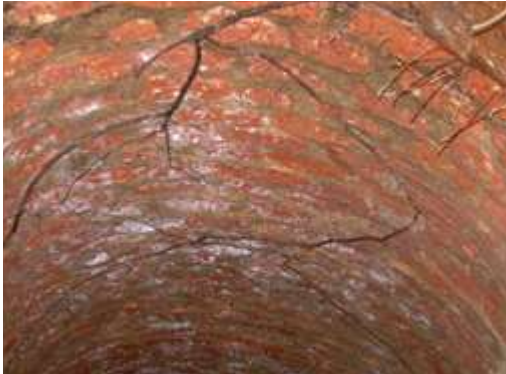
Defect

Condition: ☐ Sound ☐ Cracked ☒ **Root Intrusion** ☐ Loose Brick ☐ Deteriorated

Infiltration: ☐ None ☒ **Joint** ☐ Cracks ☐ Mortar ☒ **Roots** ☐ Wall

Infiltration: ☐ None ☐ Joint ☐ Cracks ☐ Mortar ☐ Roots ☒ **Wall**

Adjustment root intrusion and infiltration. Corbel and Barrel infiltration.

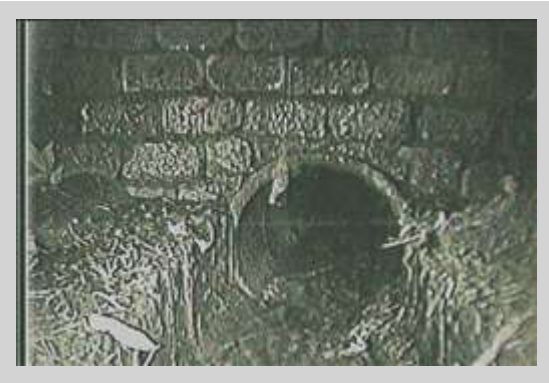
8 in. Circular Gravity Sewer Pipe Out @ 12 O'Clock

Condition: ☐ Sound ☐ Cracked ☒ **Root Intrusion** ☐ Loose Brick ☒ **Deteriorated**

Condition: ☐ Sound ☐ Cracked ☒ **Root Intrusion** ☐ Deteriorated ☐ Leaks ☐ Debris

Barrel, Bench and Channel root intrusion.

Infiltration: **Evidence** Pipe Seal Cond: **Roots**

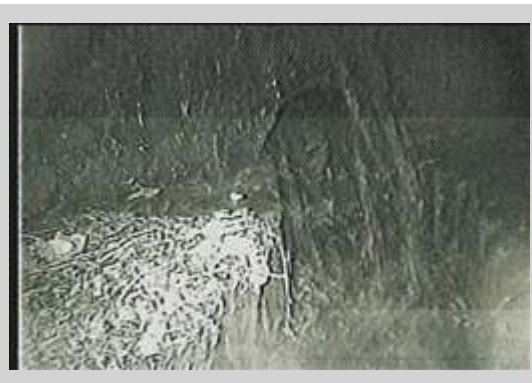
Drop In @ 5 O'Clock

Barrel deterioration and infiltration. Bench root intrusion.

Drop Condition: **Partly Clogged**
